In-filled reservoir serving as sediment archive to analyse soil organic carbon erosion – Taking a closer look at the Karoo rangelands

Juliane Krenz*¹, Philip Greenwood¹, Brigitte Kuhn¹, Goswin Heckrath², Ian Foster³, John Boardman⁴, Mike Meadows⁵, Nikolaus Kuhn¹

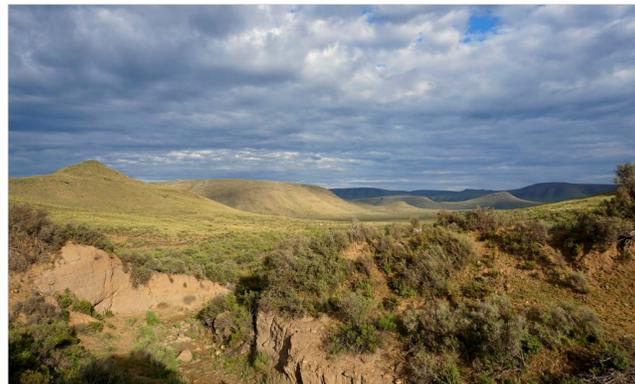
Fig. 1. View on the breach of Dam53 (front) surrounded by rangelands within the great Karoo, South Africa.
